**Phase 2 Stream Geomorphic Assessment
of
Walloomsac River and Roaring Branch,
Bennington County, Vermont
FINAL REPORT**

March 2007

Executive Summary

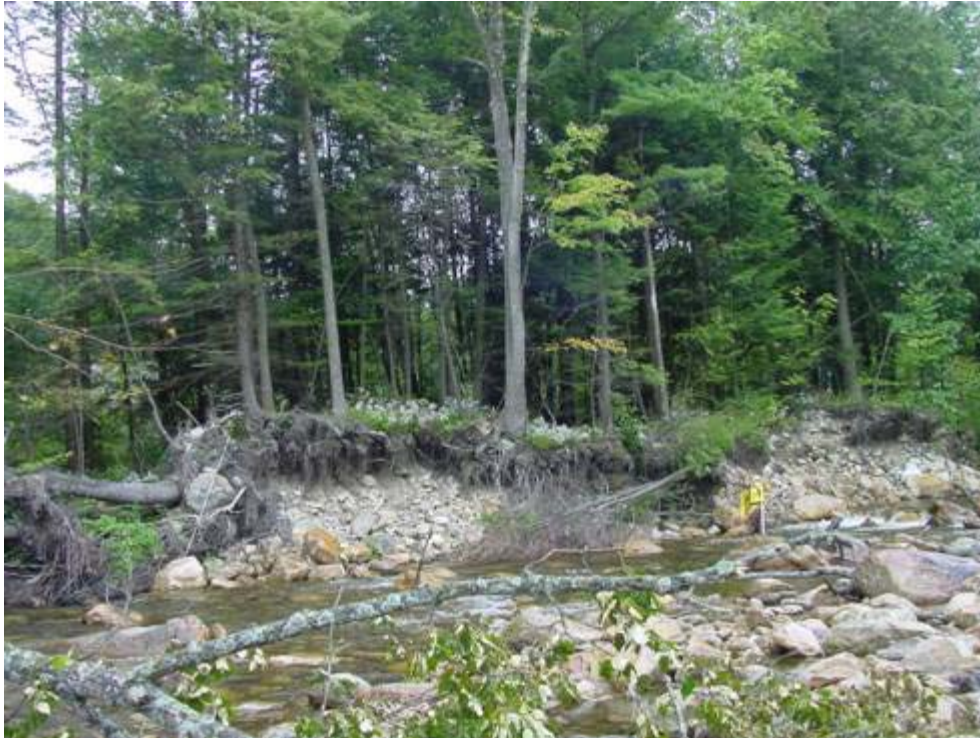
The RGA score of 0.54 indicates that the channel is considered to be in fair condition and appears to be undergoing planimetric adjustment. The channel here has also been dredged several times (USACE 1975). In addition to the historic channel dredging, some berms have been constructed to protect the road. Given the extent of anthropogenic alterations to this reach, a stream condition of “fair” is appropriate. The RHA score of 0.67 indicates that the channel is considered to contain good riverine habitat. Despite the many disturbances this reach has experienced, the reach still seems to have retained good habitat characteristics.

Figure 4: Roaring Branch - Reach M06T3.04, Erosion on Right Bank.

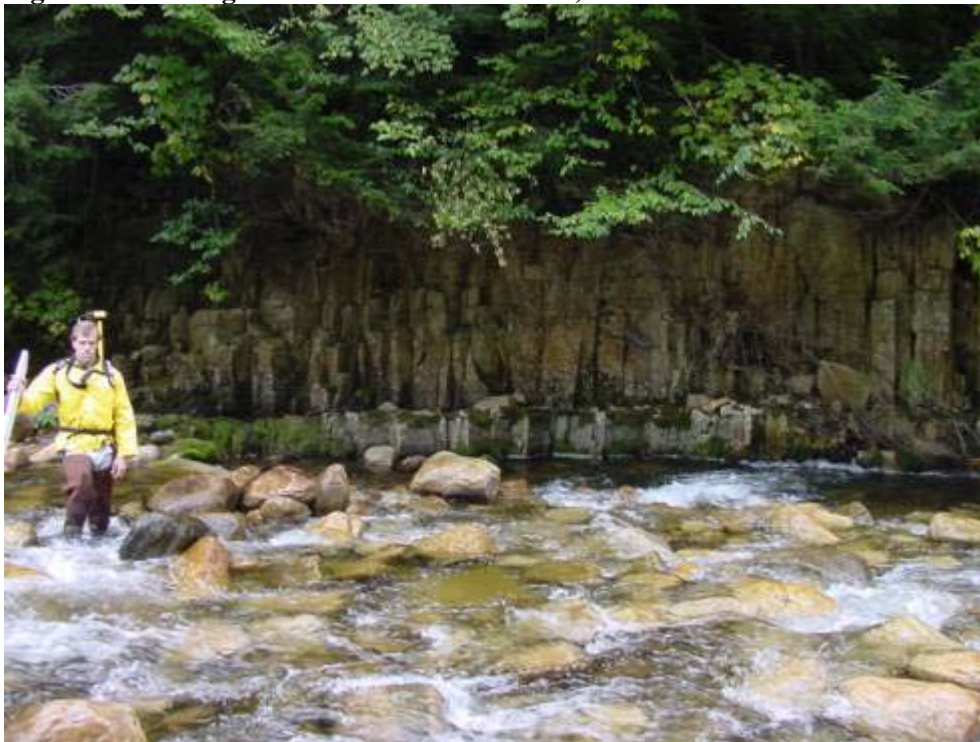
Figure 5: Roaring Branch - Reach M06T3.04, Bedrock Wall on Left Bank.

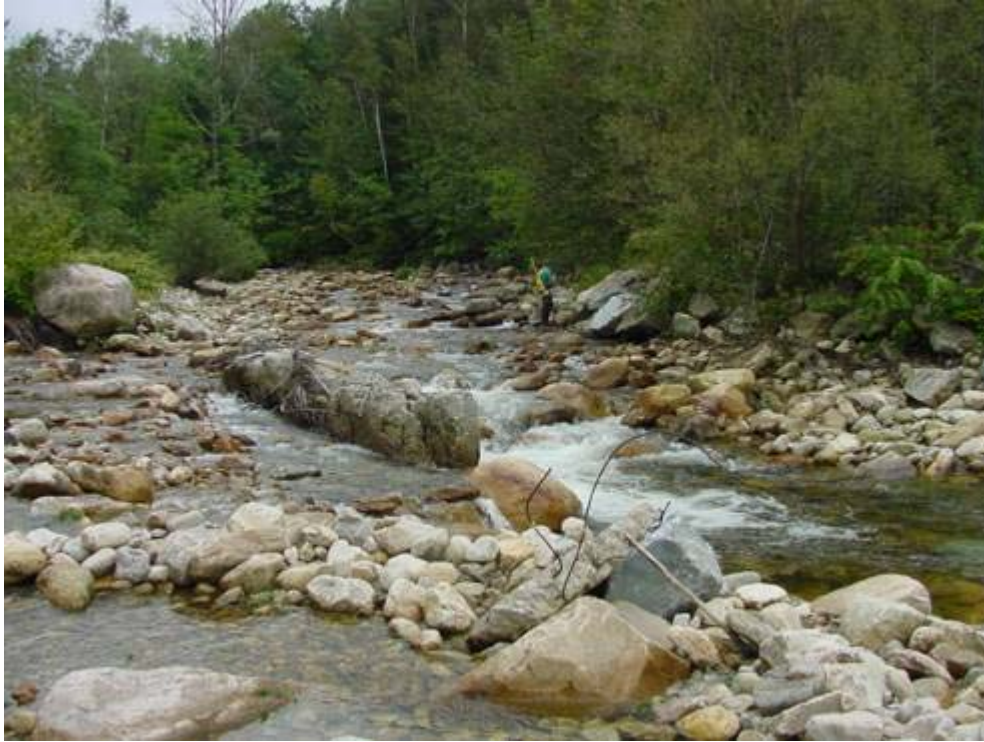
Figure 6: Roaring Branch - Reach M06T3.03, Upstream View of Old Bridge Remains.

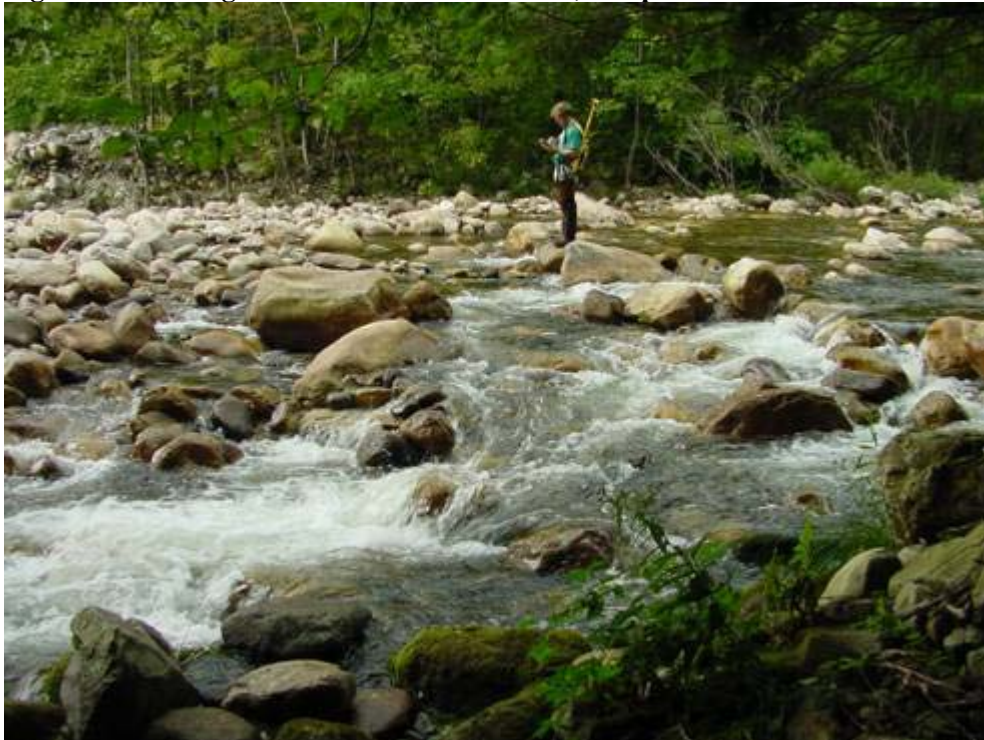
Major adjustment processes include widening, as evidenced by the creation of new channels and island formations. The representative cross-section for this reach is shown in **Figure A3**. The berming and old channels on the left floodplain are evident. The same pattern is observed at cross-section number 2 in this reach (**Figure A4**). A significant load of sediment is working through the reach as is evident from the site conditions, as many large bar features were observed. In addition to the bar features, several steepened riffles were noted which is an indication of the migration of coarse sediments (**Figure 7**).

Figure 7: Roaring Branch - Reach M06T3.03, Steep Riffle.

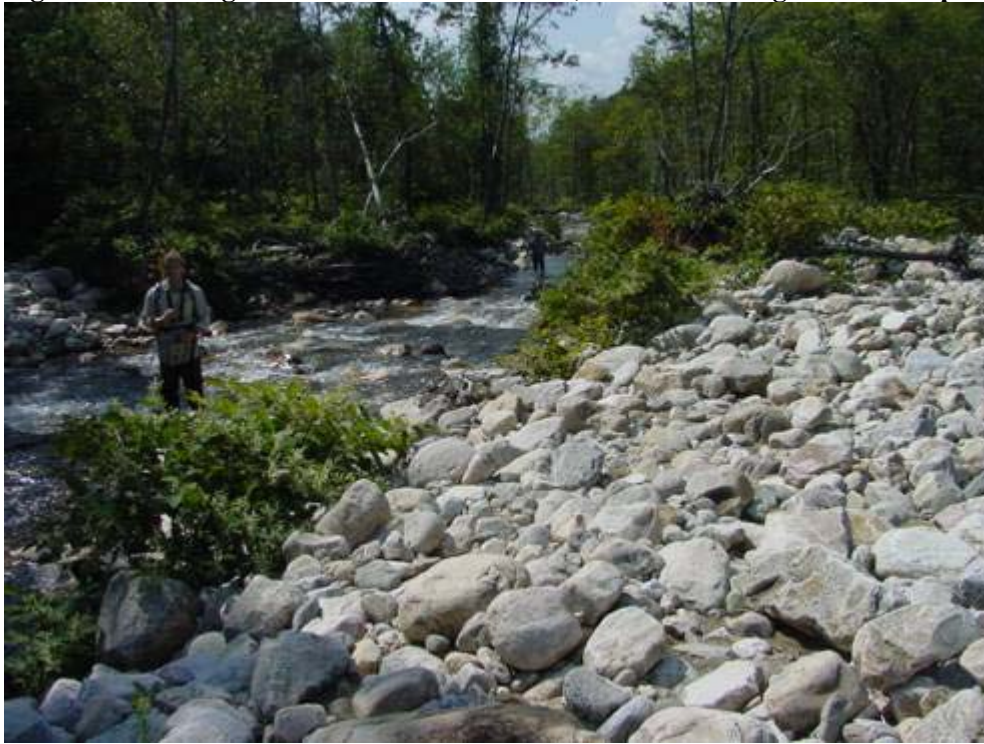
Figure 8: Roaring Branch - Reach M06T3.02, Headcut through Coarse Deposition.

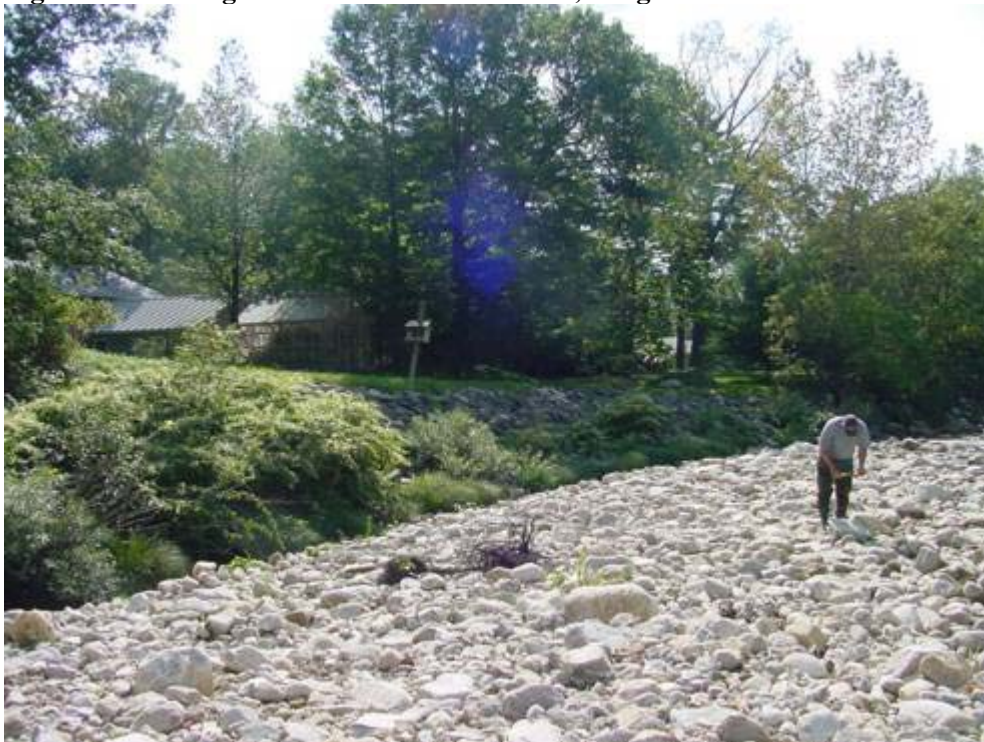
Figure 9: Roaring Branch - Reach M06T3.02, Large Side Bar near Protected Bank.

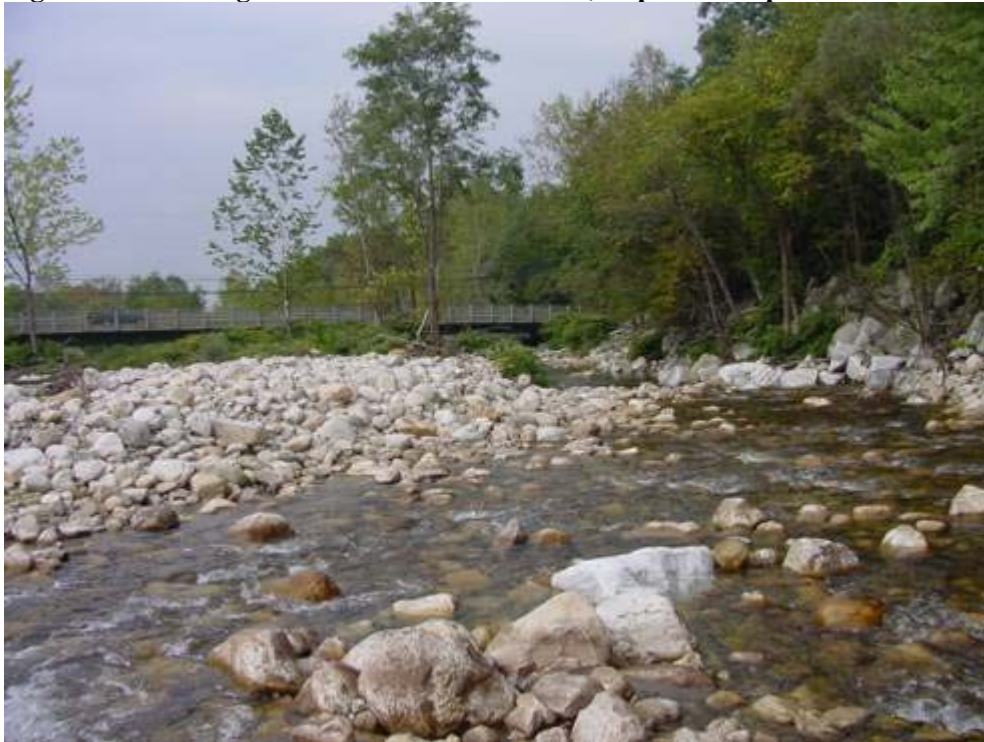
The channel constrictions at the bridges (Brooklyn, Park Street and Route 7) are causing large amounts of sediment deposition throughout the reach (**Figure 10**). These areas of deposition are currently being degraded as evidenced by headcutting through the coarse alluvial material. This cycle of deposition and degradation is expected to continue, and is re-set during larger flood events that re-deposit significant amounts of cobble and boulders in these regions. The channel also contains substantial amounts of large woody debris and bank erosion, and the reshaping of island formations within the channel is apparent (**Figure 11**).

Figure 10: Roaring Branch - Reach M06T3.01, Deposition Upstream of Park Street Bridge.

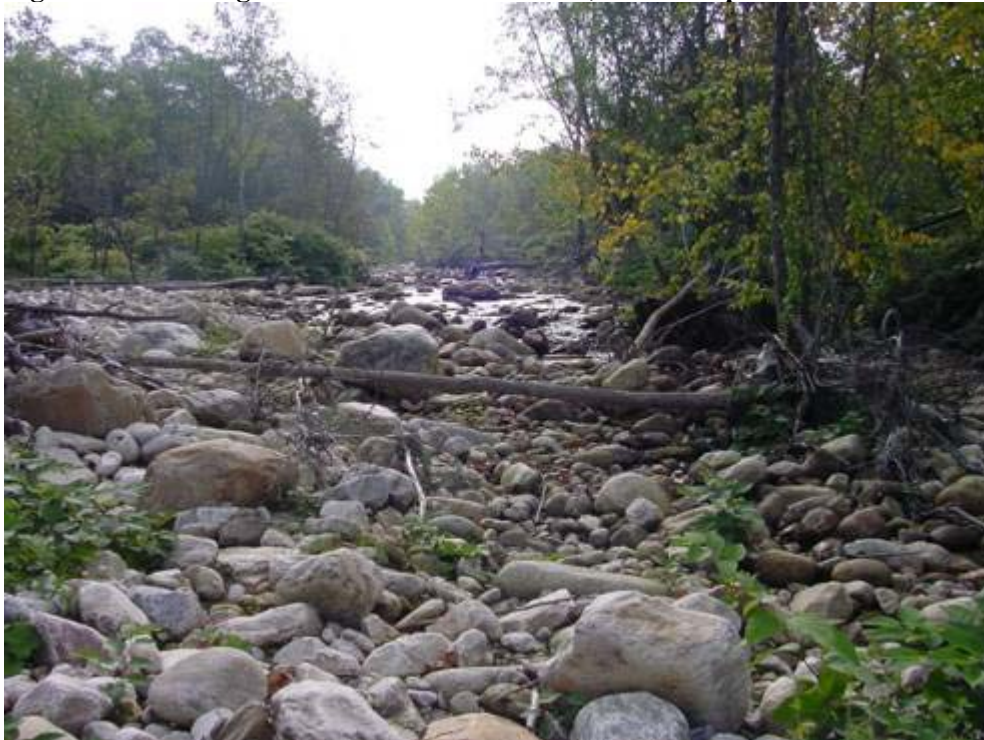
Figure 11: Roaring Branch - Reach M06T3.01, Mixed Deposition Around Island.

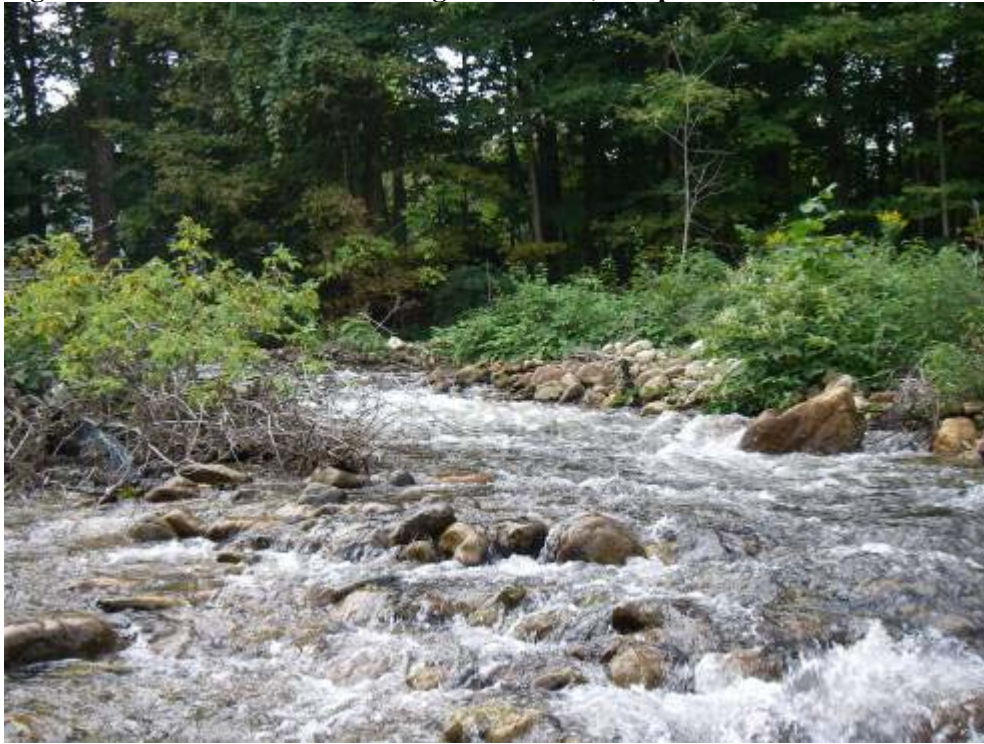
Figure 12: Walloomsac River - Segment M06b, Steep Transverse Bar.

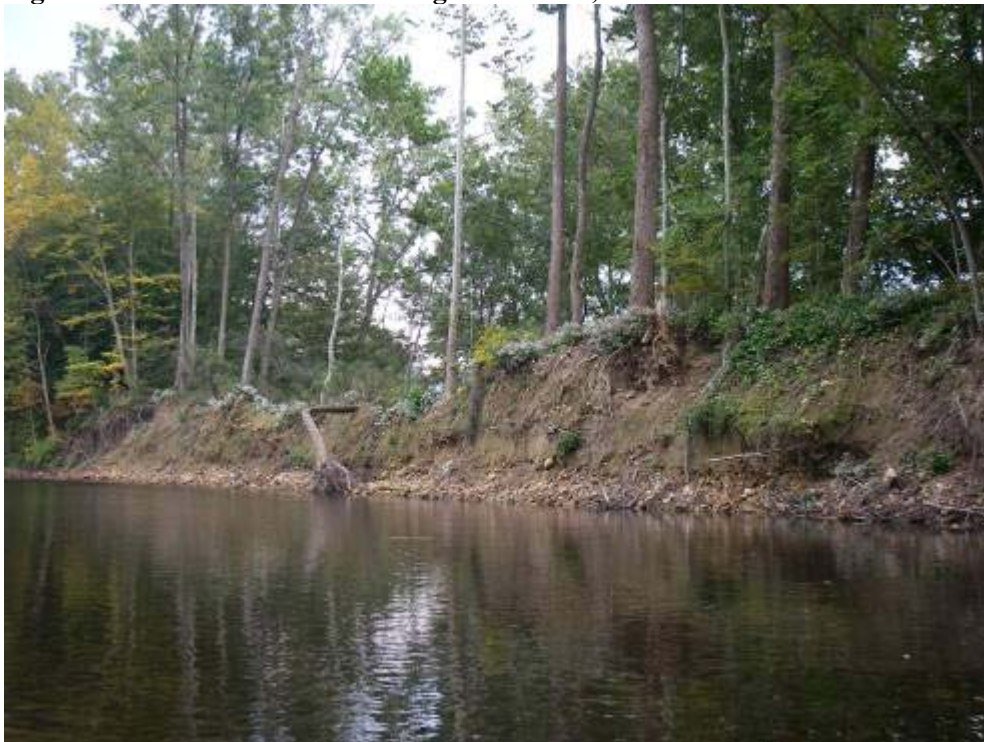
Figure 13: Walloomsac River - Segment M06b, Erosion on Left Bank.

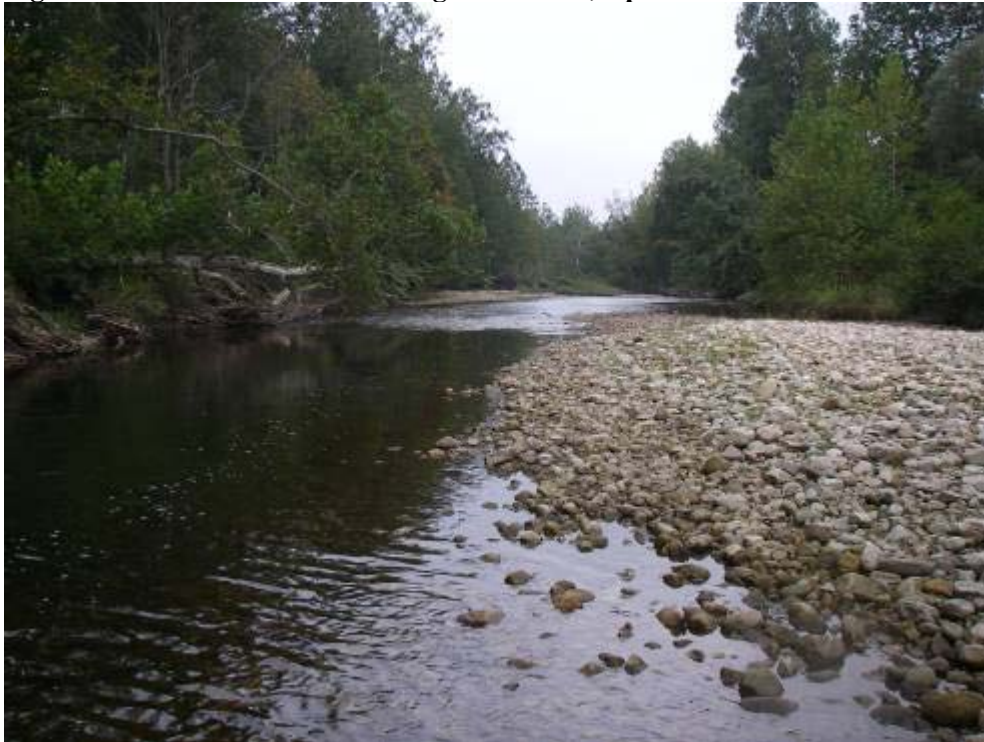
Figure 14: Walloomsac River - Segment M06a, Upstream View of Side Bar.

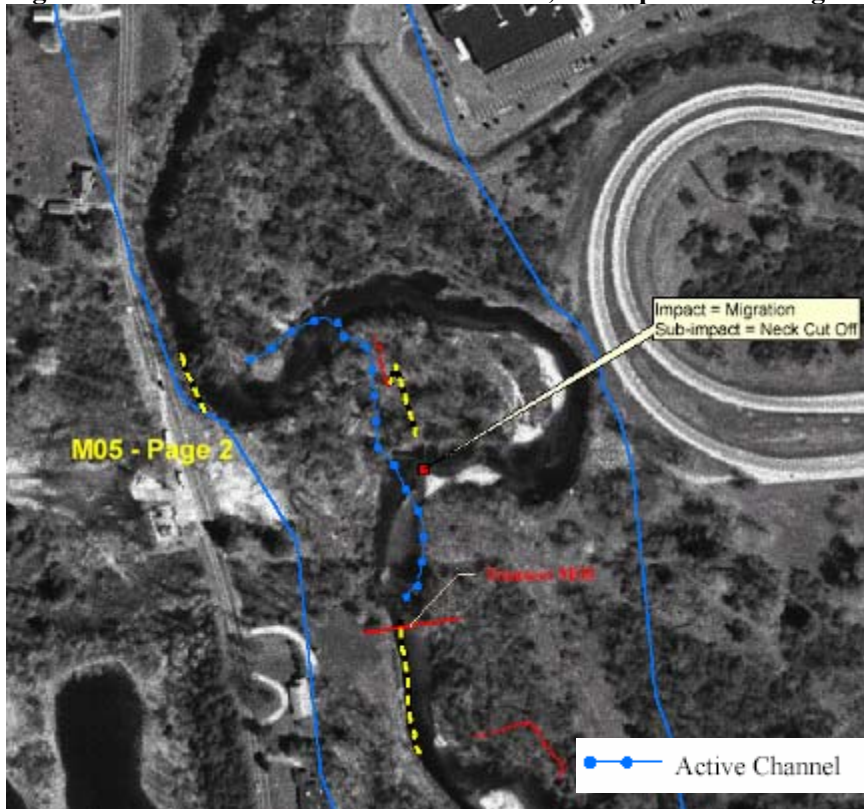
There was a significant avulsion that occurred recently in the vicinity of the Route 279 Bridge (**Figure 15**). It is not known if the bridge construction influenced this occurrence but the presence of an extreme amount of woody debris in the area indicates the possibility that a debris jam may have caused or contributed to the cut-off (**Figure 16**). Throughout the reach several smaller side bars were observed and the deposits appeared to diminish in a downstream direction. The RGA yielded a score of 0.58 which is considered to be a fair channel condition. However, it is unclear as to the nature of the recent channel avulsion beneath the bridge which contributed in large part to the low RGA score attributed to this reach. The RHA assessment yielded a score of 0.68 indicating good habitat conditions in the reach. A representative cross section was also established for this reach and is shown in **Figure A11**.

Figure 15: Walloomsac River - Reach M05, Orthophoto Showing Old Channel.

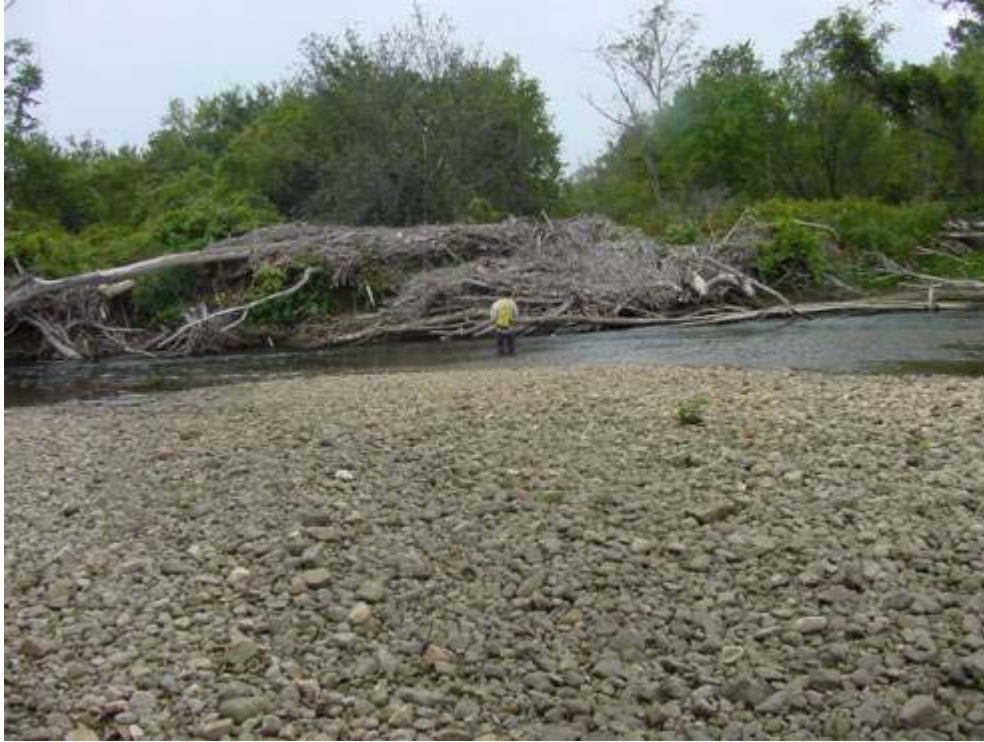
Figure 16: Walloomsac River - Reach M05, Woody Debris and Bar near Route 279 Bridge.

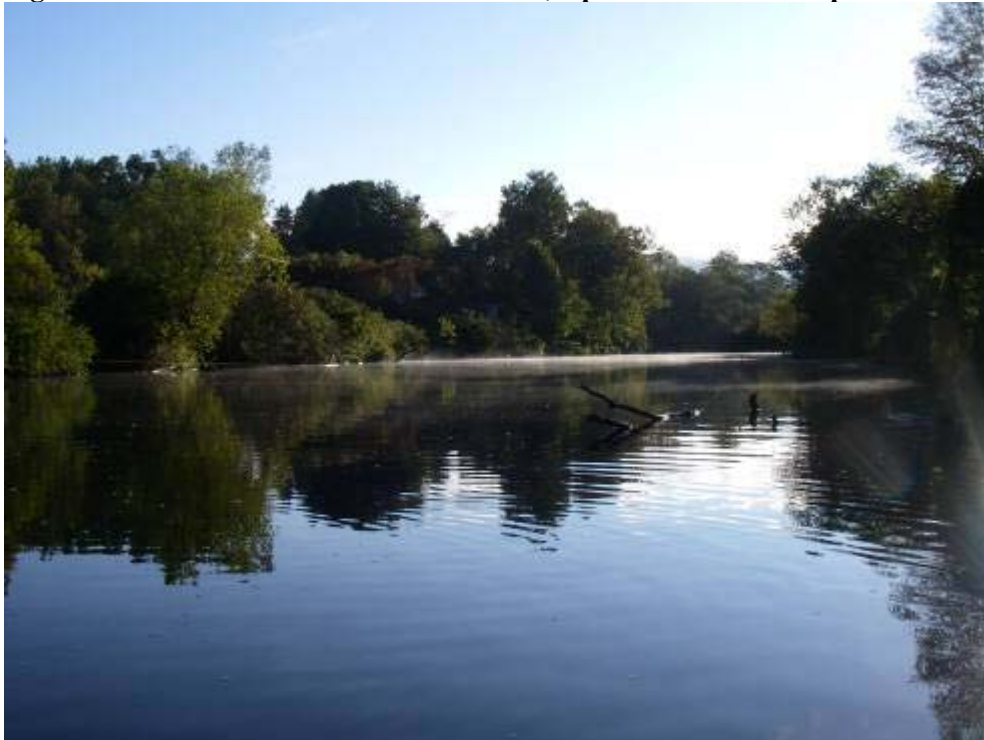
Figure 17: Walloomsac River - Reach M04, Upstream View of Impoundment.

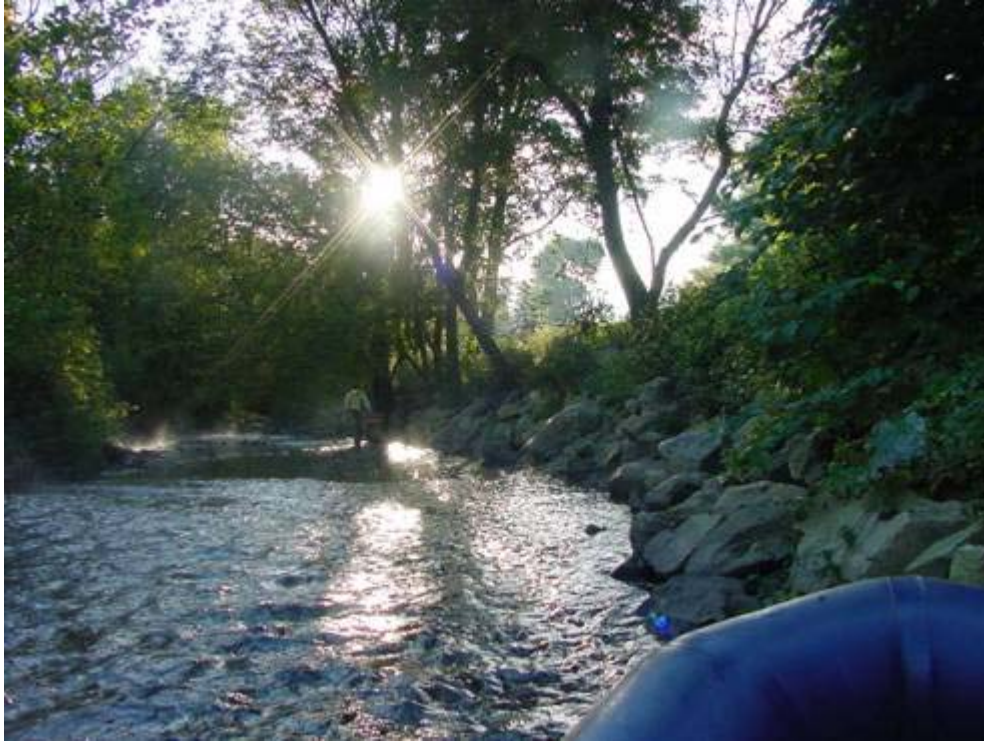
Figure 18: Walloomsac River - Reach M03, Left Bank Revetment, Upstream View.

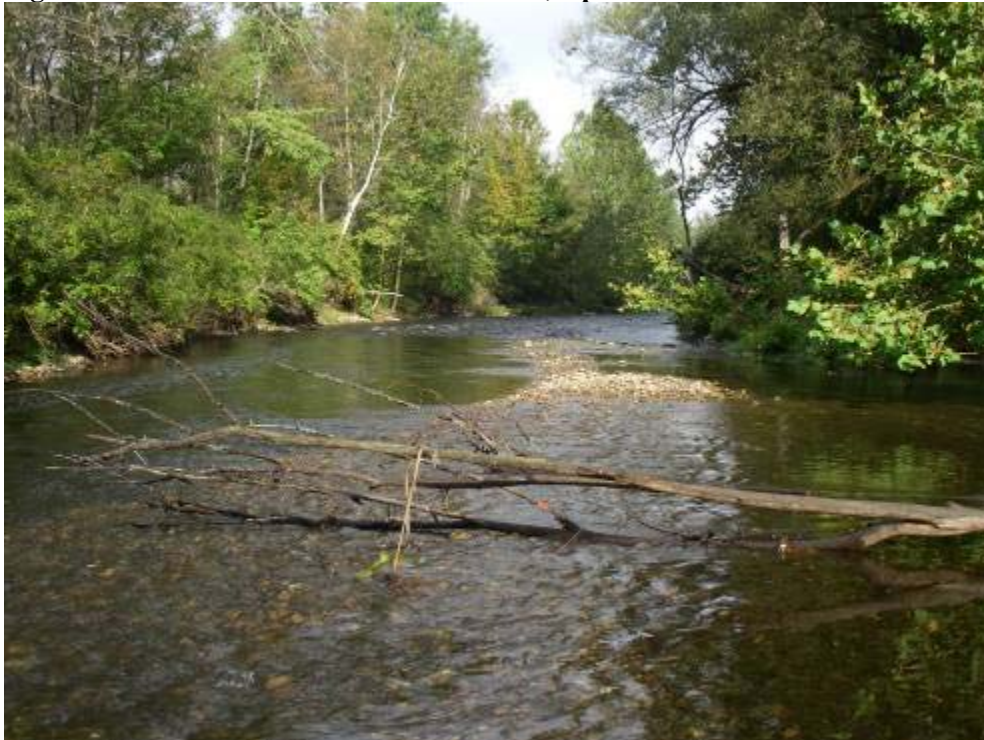
Figure 19: Walloomsac River - Reach M02, Upstream View of Channel.
